Iowa Department of Cultural Affairs
State Historical Society of Iowa
Iowa Site Inventory Form
Continuation Sheet

Name of Property _____ Central Fire Station _____ County _____ Scott _____

Address _____ 331 Scott Street _____ City _____ Davenport _____

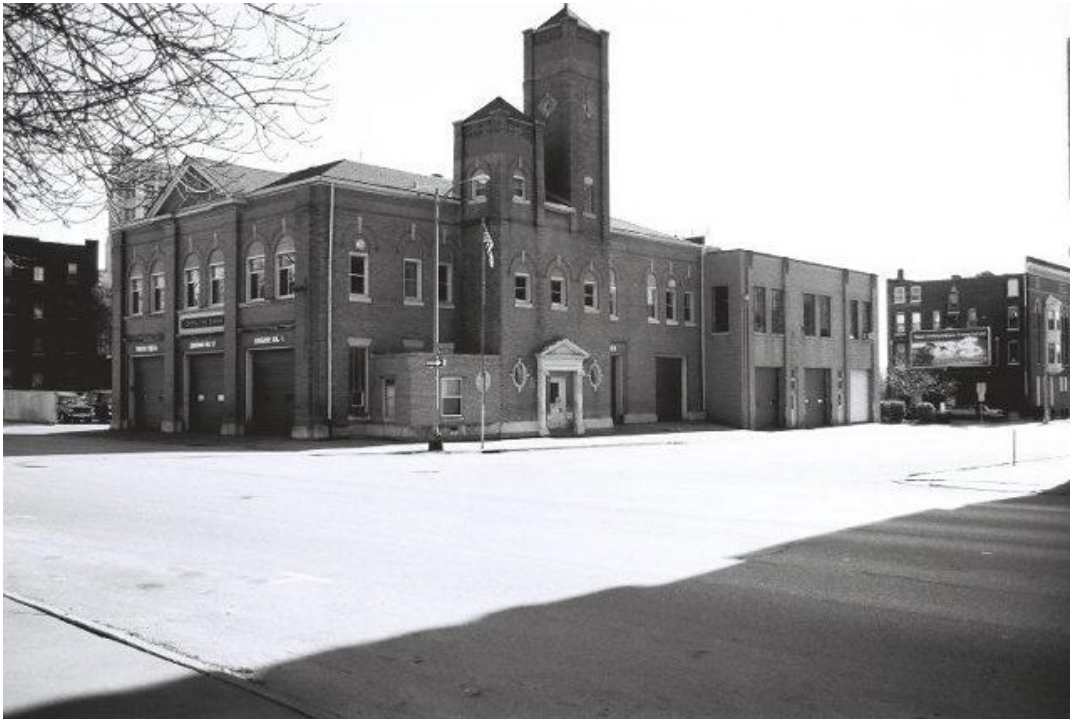
View of the north and west elevations, looking southeast across the intersection of West Fourth and Scott Streets.

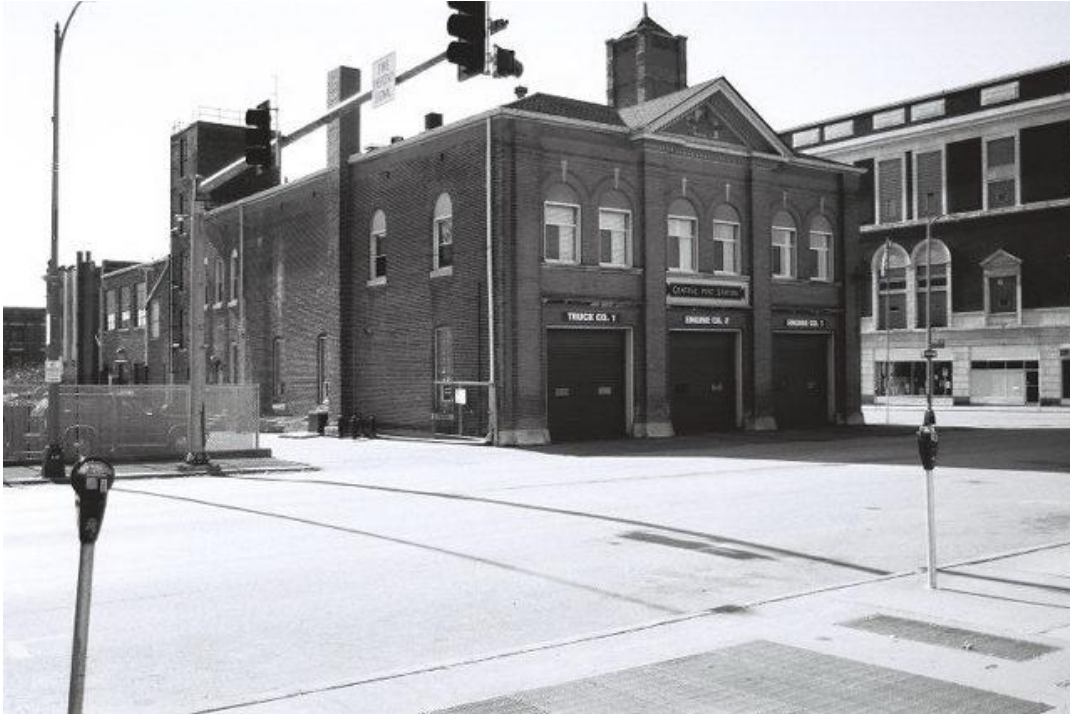
View of the north and east elevations, looking southwest across West Fourth Street.

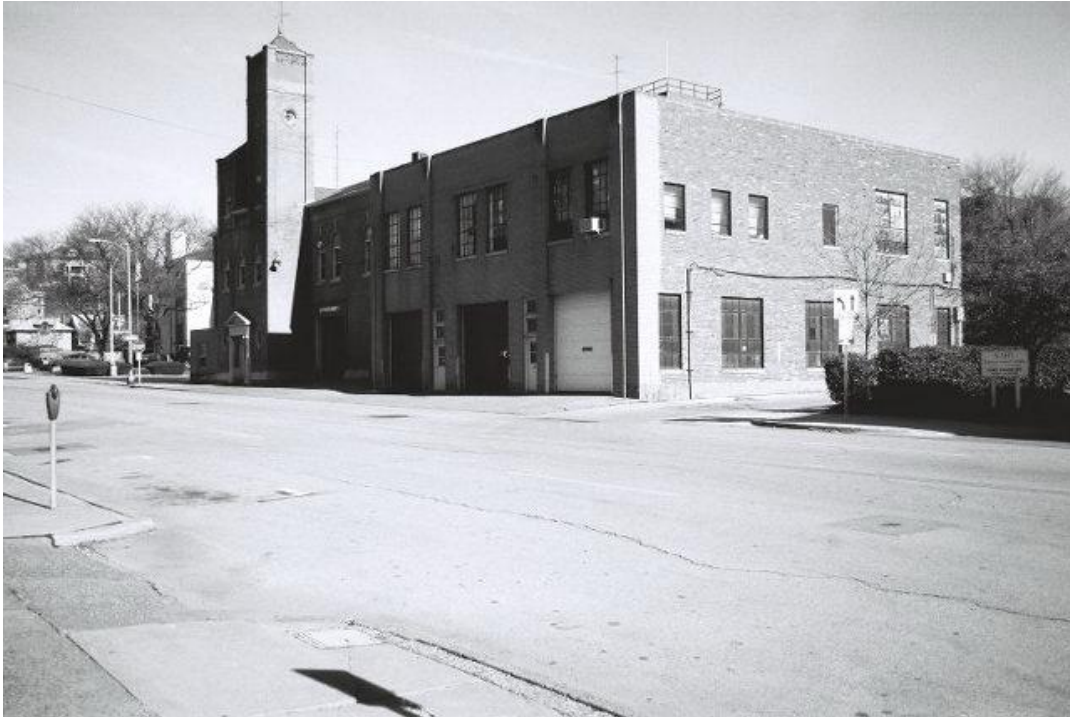
View of the west and south elevations, looking northeast across Scott Street. From this perspective, the three-bay addition to the rear is evident.

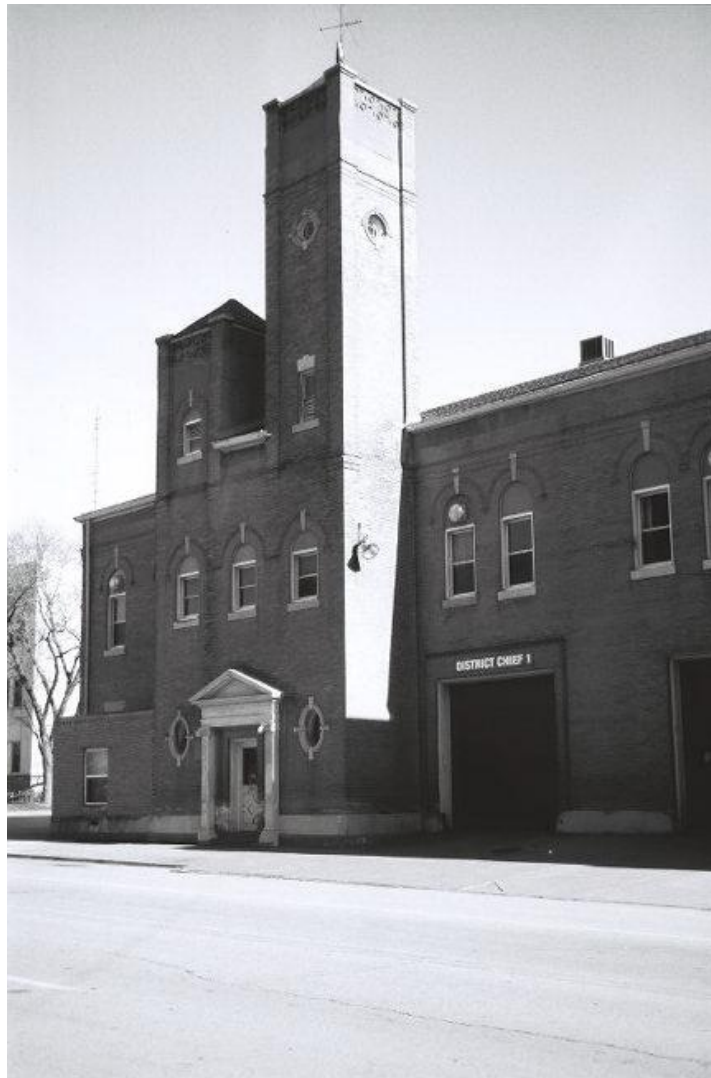
Detail view of the station's towers (west elevation.)

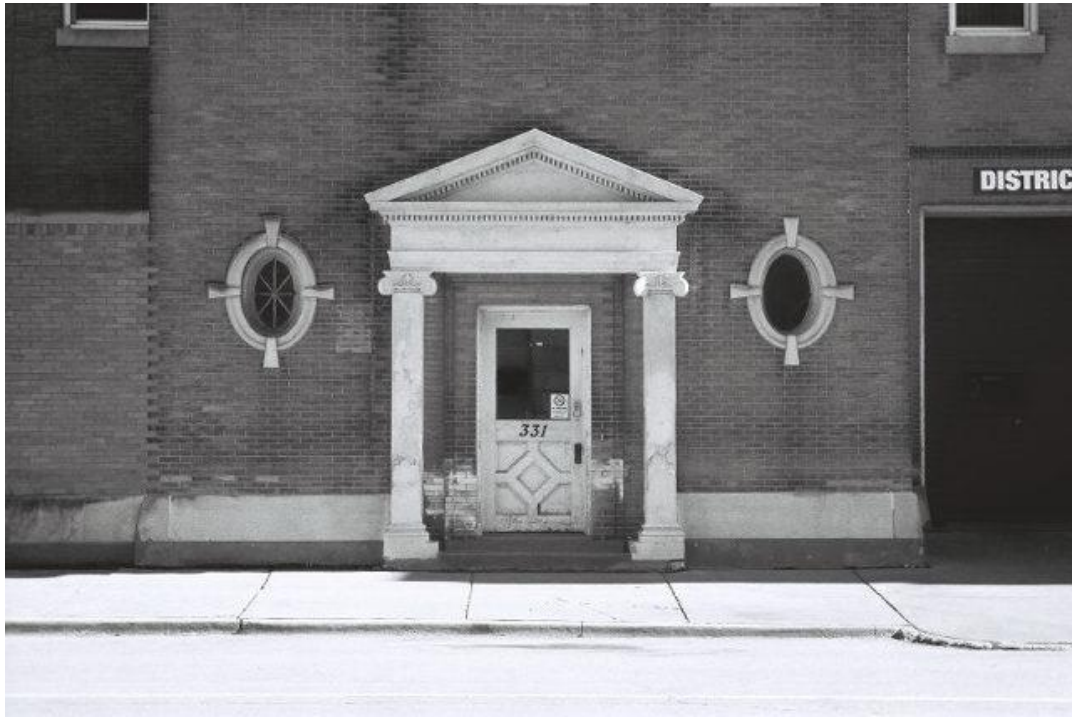
Detail view of the west pedestrian entrance. Note the use of classical elements including a pedimented entrance with Ionic columns.

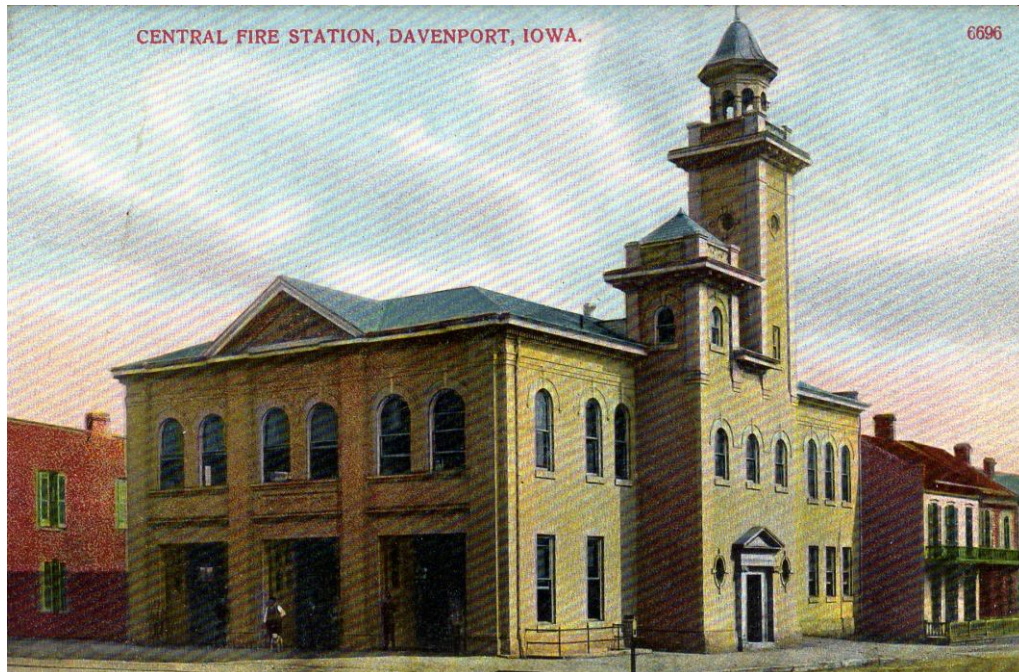
This undated postcard image documents the Central Fire Station in the early years following its 1901 construction. Note the residential buildings located south of the station; much of the downtown was heavily residential in the early years of the town's history.
